## Addingham Becks Water Quality Survey

**17<sup>th</sup> February 2025**

Addingham Environment Group

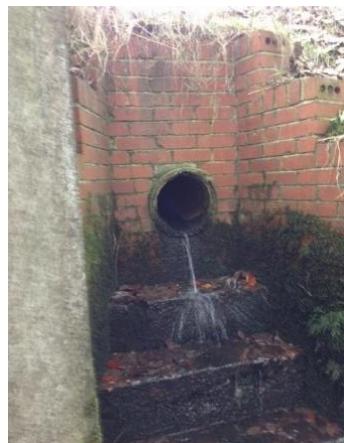
tributaries attempting to identify pollution sources. One sample (BM1, Big Meadow Drive) was taken from a pipe (see picture below), all others were taken from naturally flowing waters.

of 6°C in comparison to the main beck (ca. 4°C). They include samples from inflows that are mainly culverted and flow through and under roads and gardens (MP1 Moor Park Drive, ML1 Moor Lane, GD1 Green Dyke) or in the case of BM1 (Big Meadow Drive) is from pipeflow (see picture).
