# Sustainable Water

## Aynholme Bridge

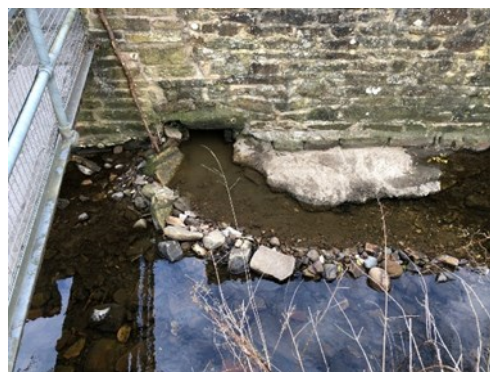
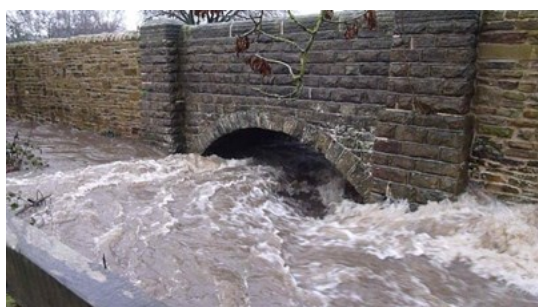
The opening of the culvert under Bolton Road that takes water from Town Beck into the Saw Mill Dam can be seen looking back at the beck just upstream of the footbridge. This is the culvert that is frequently blocked or partially blocked. A good water supply is needed to maintain the level of the water in the Dam and to prevent the water becoming stagnant. At the downstream side of the footbridge there is a small barrier across the beck recently installed by a village resident in an attempt to increase the water level of the beck as it passes the entrance to the culvert.

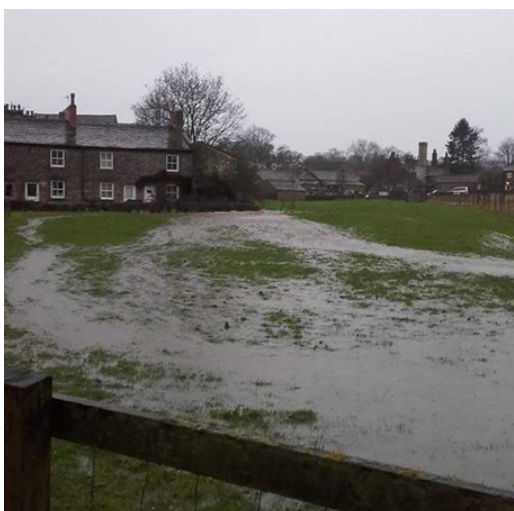
Back Beck joins Town Beck a little further downstream before Town Beck flows under Aynholme Bridge. Water flow under the bridge can be extremely high in stormy weather. The low-lying eastern part of the Garth can become occupied by floodwater in such conditions partly through groundwater rising but also, in extreme conditions, when Town Beck breaks its banks in its attempt to flow along its very artificial channel around the houses upstream.

As for the beck in the field near Bridge 55 (SW 2) and in Church Field (SW 8) the beck in the Garth has been re-aligned to flow around the edge of the field. These channels were probably created a long time ago, probably well before the 19<sup>th</sup> century, to improve the fields they were flowing through for growing crops.

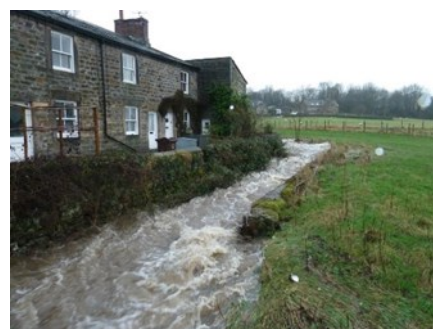
Here and in the other fields the floodwaters occupy the low-lying ground indicating the likely former more natural route for the water. Today these former channels could be reactivated to create wildlife habitats and to slow the flow of floodwaters.
